# Service Bulletin

Bulletin No.: 03-08-06-001

**Subject:** Bubbles in the Paint Around the Perimeter of the Roof (Replace Roof)

**Models:** 1999-2002 Chevrolet Camaro  
1999-2002 Pontiac Firebird

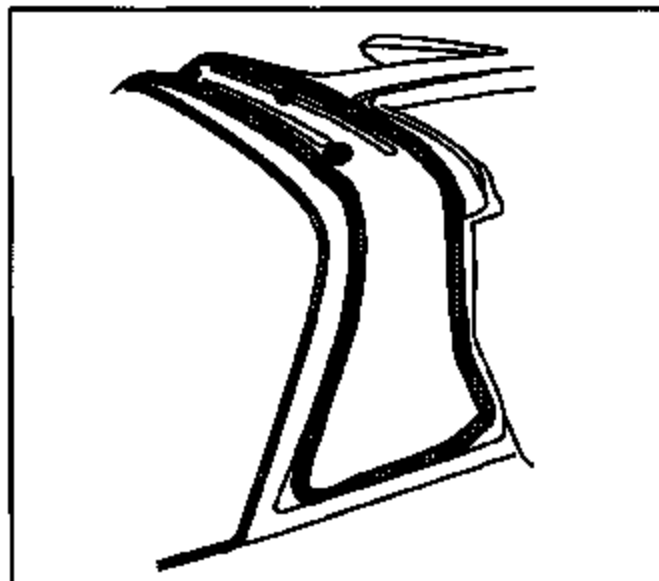
1233108

Some customers may comment that there are bubbles in the paint around the perimeter of the roof.

5. Use the wire method to cut the urethane around the perimeter of the roof. Refer to the above illustration for urethane location.
6. Remove any excess but not all of the urethane from the body.

7. Apply primer 76 mm (3 in) around the perimeter to the roof panel.
8. V cut the urethane tube and apply a 19 mm (3/4 in) high bead around the perimeter of the roof and the three dots across the back.
